A new bioactive cement for direct pulp capping

Till Dammaschke¹

Abstract

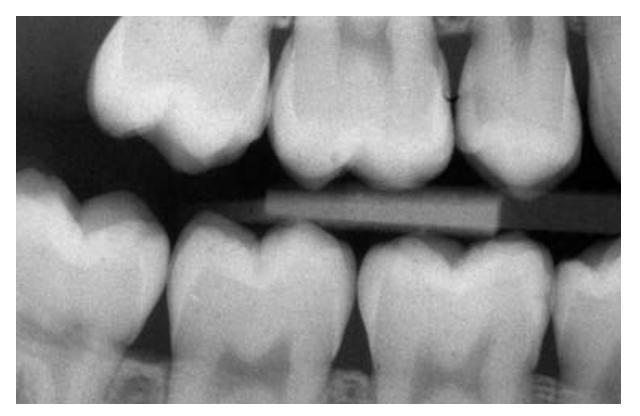
Figure 1: Bitewing film of quadrants 1 and 4 of a patient aged 18 years at the time. Note the proximal carious lesion on tooth 15 distally. The patient did not show up at the scheduled appointment for filling.

Four years ago a male patient, then 18 years old, came for a routine check-up. Bitewing films recorded during the diagnostic assessment showed signs of an approximal carious lesion distally on tooth 15 (Figure 1). The patient was informed about the need to have the carious lesion treated, but failed to keep the scheduled appointment. At age 22 he returned, complaining of discomfort of tooth 15 on contact with cold food, drinks and air apparently caused by a buccal enamel fracture of the tooth. On examination, a deep approximal carious lesion was found distally. The tooth was tested positive on CO_2 snow sensitivity and negative on percussion. After thorough information of the patient, an anesthetic (Septanest, 1 ml; Septodont, St. Maur-des-Fossés, France) was injected for terminal anesthesia and a rubber dam was put in place. Following cavity preparation the carious dentin was completely excavated. In the process the pulp cavity was exposed iatrogenically at two sites (Figure 2). Clinically the pulp tissue was vital without any major bleeding, so that maintenance of tooth vitality by direct pulp capping was decided upon. NaOCI (2.5%) was applied for hemostasis, clearing and disinfecting the cavity. Biodentine™ (Septodont, St. Maur-des-Fossés, France) was chosen for direct pulp capping. Mixed as recommended by the manufacturer, Biodentine[™] was applied to the exposed pulp

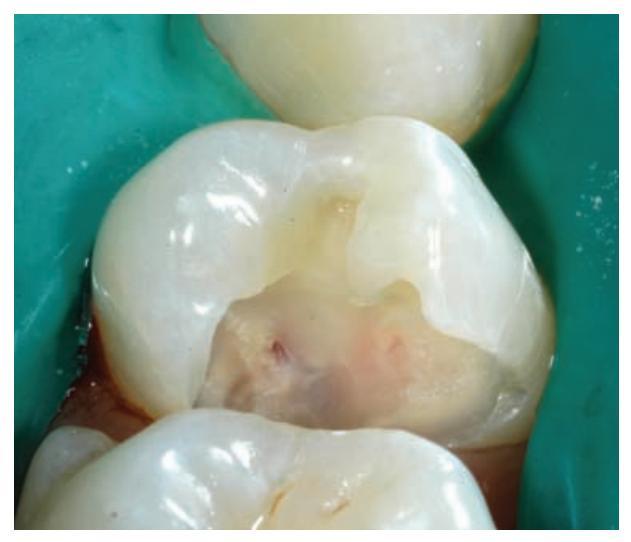
Figure 2: When the patient returned 4 years later, iatrogenic pulp exposure occurred at two sites during complete caries excavation.

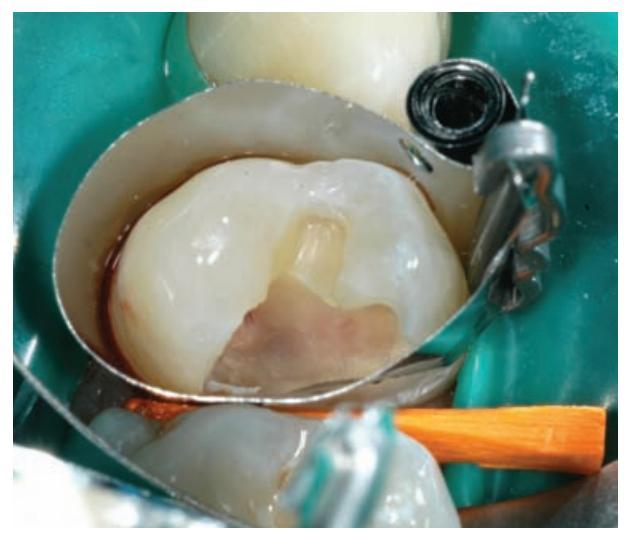
Figure 3: For filling the cavity and for direct capping with Biodentine™ (Septodont; St. Maur-des-Fossés, France) a matrix band (AutoMatrix; Dentsply-Caulk, Milford, DE, USA) and wedges were put in place.

tissue for direct capping and for temporary restoration. After placing a matrix band (AutoMatrix; Dentsply-Caulk, Milford, DE, USA), (Figure 3), the entire cavity was filled with the bioactive cement (Figure 4) . About twelve minutes after mixing, when the Biodentine[™] had set, occlusion was checked (Figure 5). At the follow-up visit 4 days after direct capping the patient reported some increased cold and warm sensitivity of tooth 15, but no other subjective symptoms.

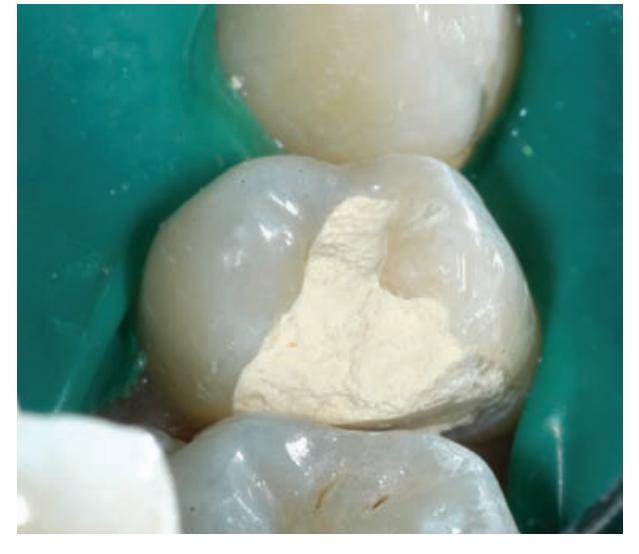
Figure 4: Biodentine™ was applied to the cavity with cement pluggers using light pressure. Carving instruments were used for occlusal adjustment. Biodentine™ should not be prepared with rotating instruments and should not come into contact with water.

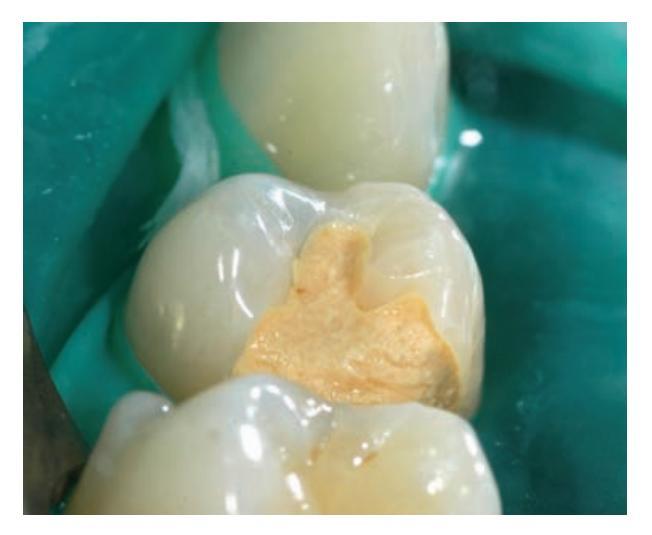
Figure 6: Three months later the patient returned to have the cavity definitively filled with composite. At this visit the Biodentine™ filling showed marginal material loss.

Three months after direct capping he returned to have the Biodentine[™] filling (Figure 6) partially removed and covered by a composite filling to replace enamel.. The symptoms he had originally reported had completely disappeared within a very short time. Tooth 15 was clinically normal and tested

Of note, Biodentine[™] fillings were found to show marginal material loss at the follow-up visit after 3 months. This may be attributable to incorrect handling. During occlusal adjustment, Biodentine[™] should not be prepared with rotating instruments and should not come into contact with water. It should rather be applied into the cavity with cement pluggers using light pressure, and carving instruments should be used for occlusal adjustment. Subsequent polishing of the Biodentine[™] filling should be omitted. Excessive pressure or exaggerated trimming and polishing may disrupt the crystalline structure of Biodentine[™] with resultant loss of material strength.

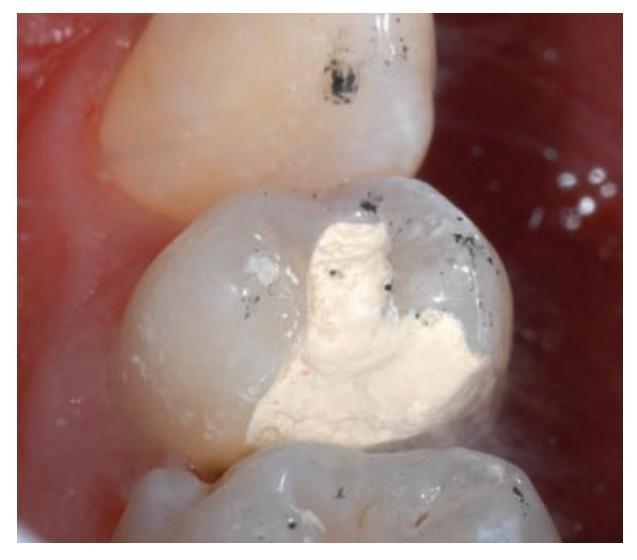
Figure 5: After allowing 12 to 15 minutes for Biodentine™ to set the bite was checked. Subsequent polishing of the Biodentine™ filling should be omitted.

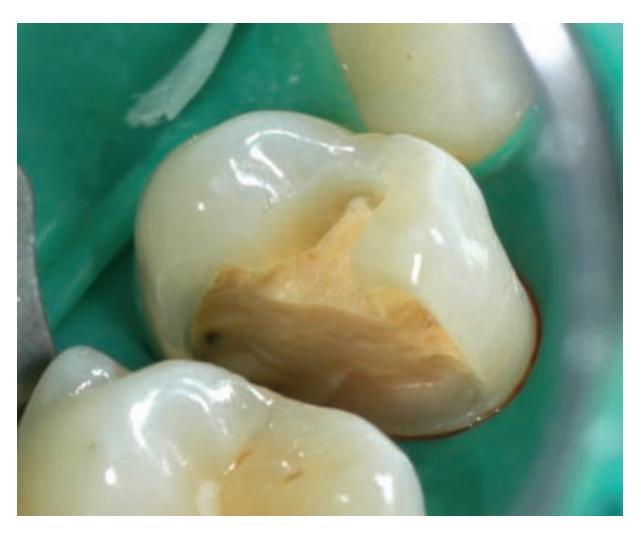
Figure 7: Biodentine™ reduced to a base/dentin substitute level.

positive for sensitivity and negative for percussion. An anesthetic (Septanest, 1 ml; Septodont, St. Maur-des-Fossés, France) was injected for terminal anesthesia and a rubber dam was placed. The Biodentine[™] filling was reduced and kept as a base/dentin substitute (Figure 7) and a matrix band as well as wedges (Composi-Tight 3D; Garrison, Spring Lake, MI, USA) were applied (Figure 8). Then the entire cavity was etched with phosphoric acid, and a dentin adhesive (Optibond FL; Kerr, Orange, CA, USA) and a composite (Grandio; VOCO, Cuxhaven, Germany) were applied (Figures 9 and 10). At the follow-up visit 6 months after direct capping, tooth 15 was clinically normal and again tested positive for sensitivity and negative for percussion. The

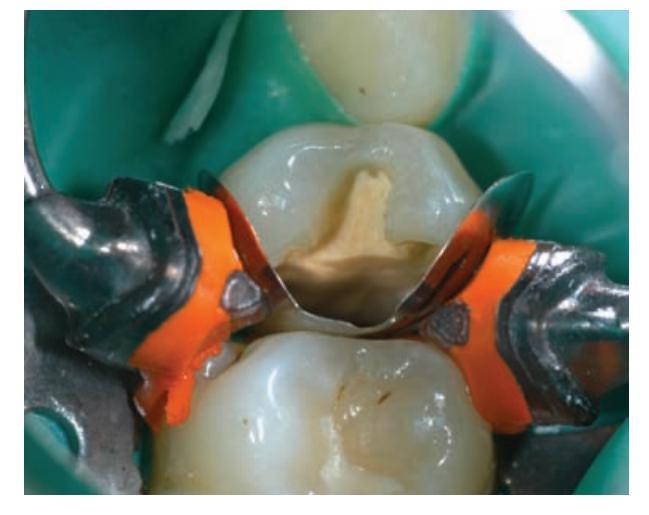
Figure 8: Before restoring the cavity with composite a matrix band (Composi-Tight 3D; Garrison, Spring Lake, MI, USA) and wedges were put in place.

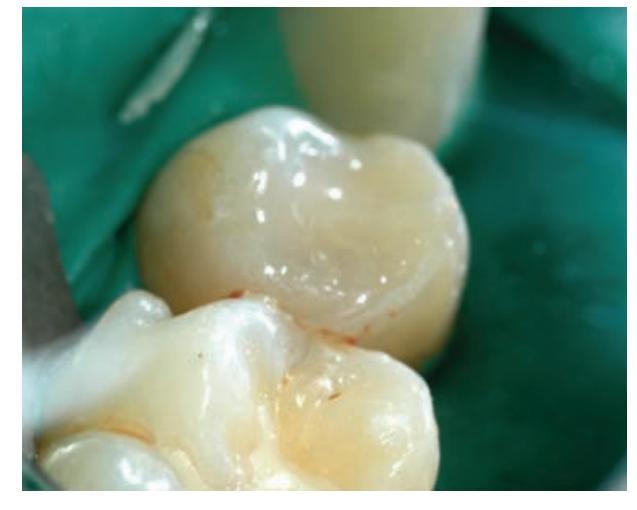
Figure 9: Cavity filled with composite (Grandio; VOCO, Cuxhaven, Germany).

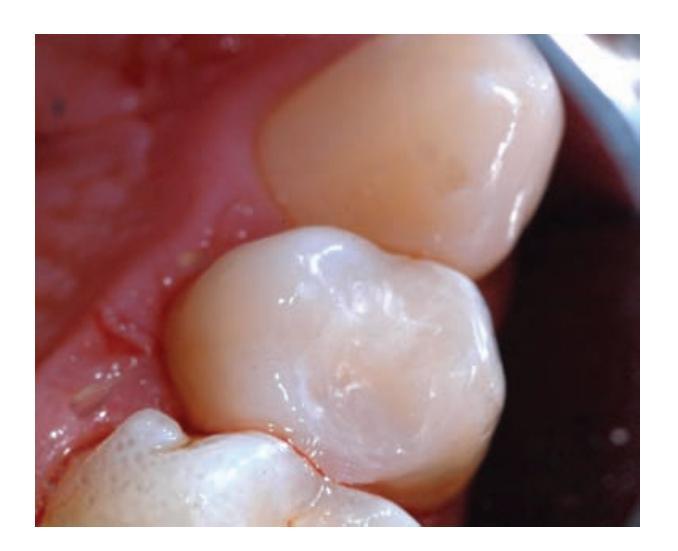
Figure 10: Finalized and polished composite filling.

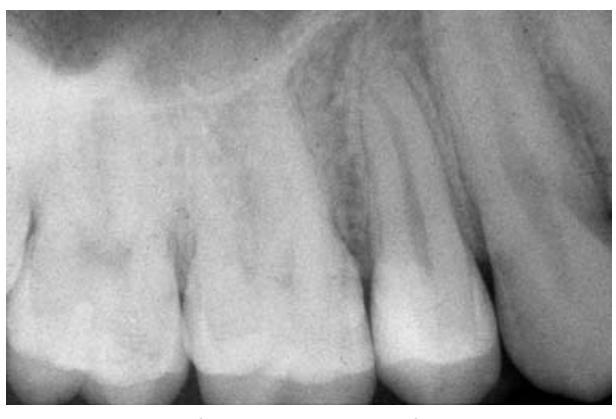
Figure 11: The dental film recorded 6 months after direct capping does not show any pathological findings apical of tooth 15.

dental film recorded at that time did not show any pathological findings apically (Figure 11).
